# SETUP MANUAL

## ***Midmark Products over Thin Client using IQpath®***

Version 3.0

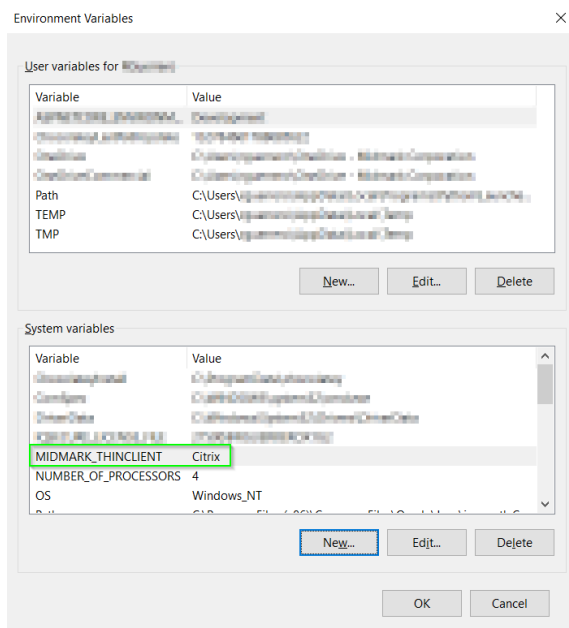
Create an environment variable for Citrix, RDP, or VMware depending on the server (or VM computer).

MIDMARK\_THINCLIENT=<type>

If the environment variable is not created, a Windows Registry item must be created and set to Citrix, RDP, or VMware.

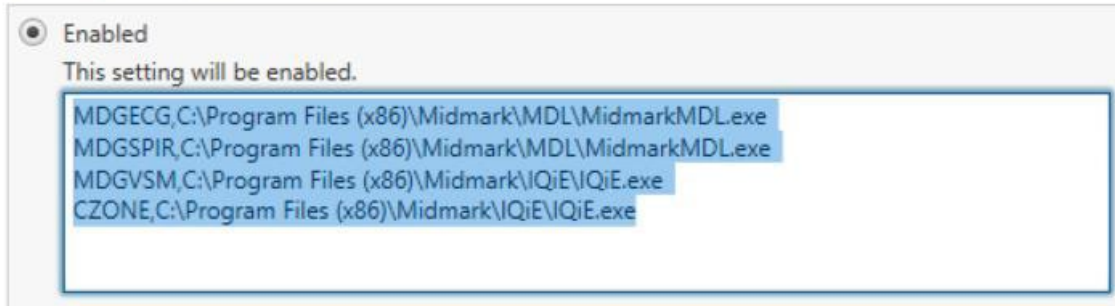
### Virtual channel allow list

Then use Citrix Studio on the Citrix Server to set up the virtual channel policy and include the Midmark custom channel items to virtual channel ALLOW LIST. Depending on your organization settings, the clients will need to wait until the policy is updated before the changes are applied.

Each row on the Allow List represents a custom virtual channel. The first item is the virtual channel name. The second is the path to the executable program which calls the module where the named virtual channel is opened and connected to the client computer. The Allow List accepts only all upper-case channel name. But the program code can use any case for the channel name.

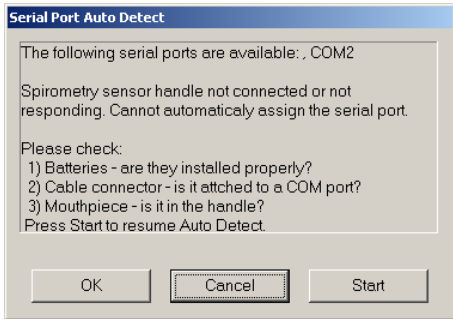
Vitals IQpath® Troubleshooting Guide	
Error Message or Problem	Solution or Recommendation
<p>A pop up dialog with the following message appears:</p> <p><b>Error: Unable to write to the Midmark VMware Spirometry virtual channel.</b></p>	<p>The Spirometry software running on the server computer was not able to write to the VMware IQpath driver DLL on the client computer.</p> <p>One possible cause for this problem may be that the IQpath driver DLLs have not been installed on the client computer. Install the Midmark IQpath® for VMware on the client computer and try again.</p> <p>Another possible cause is that registry keys for the current user have not been set. Terminate the thin client session and run the MidmarkVMwareVDI.reg file located in the C:\Midmark\ThinClient directory.</p>
<p>The following dialog box appears.</p>

<p>This is the auto-detection dialog box used for automatically detecting the Spirometry module when running as a fat-client or when using COM port mapping in a thin client environment.</p> <p>If this dialog box appears, then the Spirometry software did not detect it is being run in a thin client environment.</p> <p>To override the auto detection, choose Option 1 or 2 below:</p> <ol style="list-style-type: none"> <li>1. Add environment variable MIDMARK_THINCLIENT=&lt;type&gt;</li> </ol> <p><b>OR</b></p> <ol style="list-style-type: none"> <li>2. Add registry Key HKEY_LOCAL_MACHINE/Software/Midmark/ThinClient/ThinClientType=&lt;type&gt;</li> </ol> <p>Where &lt;type&gt; is of the following: "citrix", "rdp", or "vmware"</p>
